COASTAL RESTORATION CASE STUDY

Shorters Wharf Tidal Marsh Resilience Project

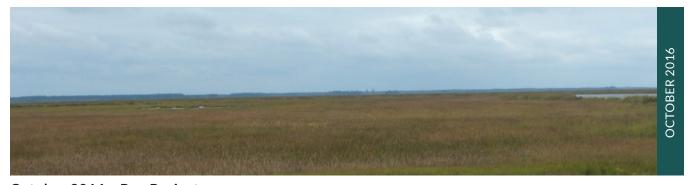
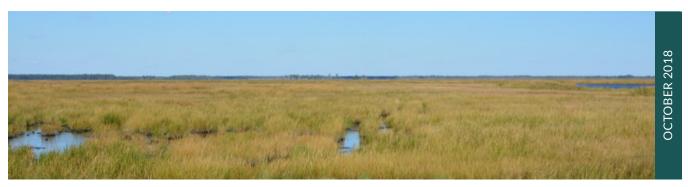
Figure 1. Source: Whitbeck, M., A. McCullough, E. Meyers, and D. Curson, Shorters Wharf Tidal Marsh Resilience Project: Implementation Report, 2019, The Conservation Fund (Arlington, Virginia)

October 2016 - Pre-Project

May 2017 - Immediate post-thin-layering

October 2018 - Two growing seasons following thin-layer addition
