## Indicator 1: Wet and Muddy Areas

# Recreation Trail Stewardship Scorecard: Sample Datasheet

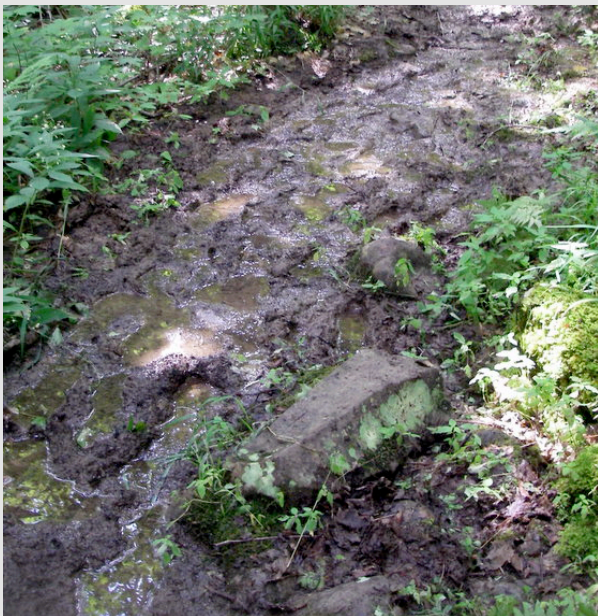
### Moderate

New or existing footprints or tracks  
>2 inches but not <6 inches in  
depth

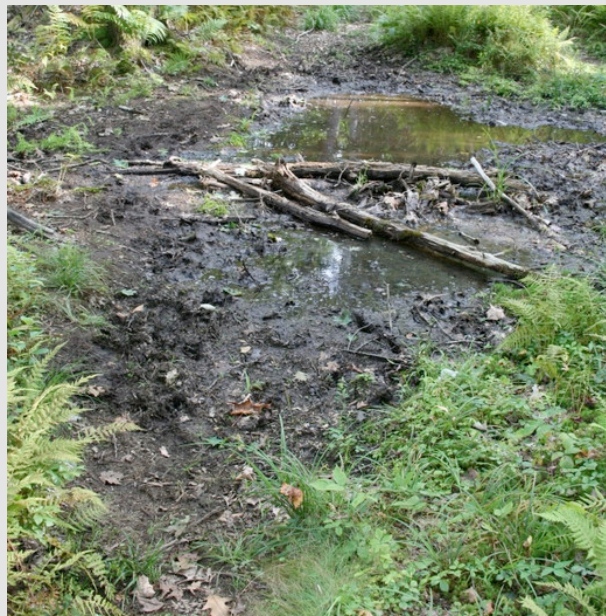
### Severe

New or existing footprints or tracks  
>6 inches in depth

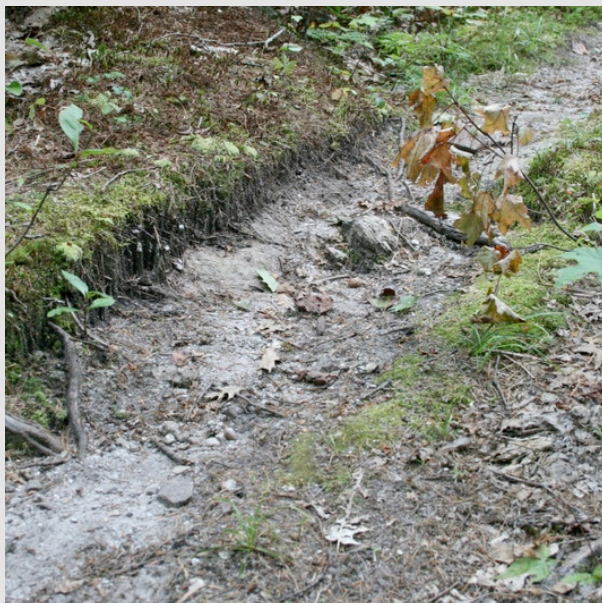
### Moderate

Ruts or gullies between 2-6 inches deep anywhere within eroded trail segment

Differences between trail and surrounding ground between 2-6 inches deep anywhere within eroded trail segment

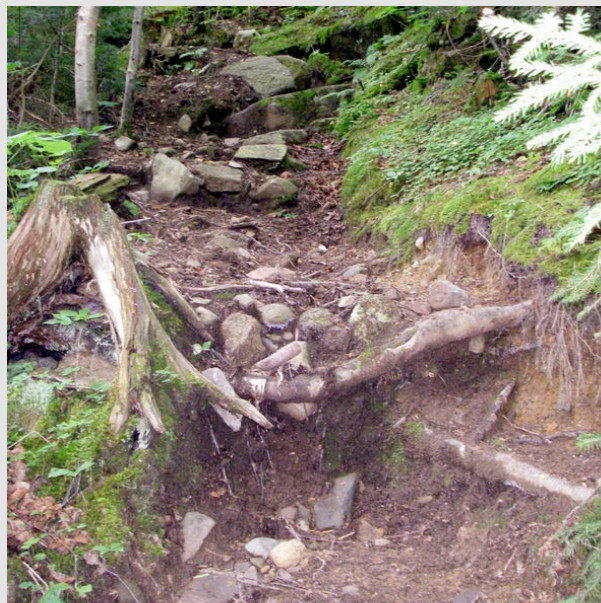
### Severe

Ruts or gullies >6 inches deep anywhere within eroded trail segment

Differences between trail and surrounding ground >6 inches deep anywhere within eroded trail segment

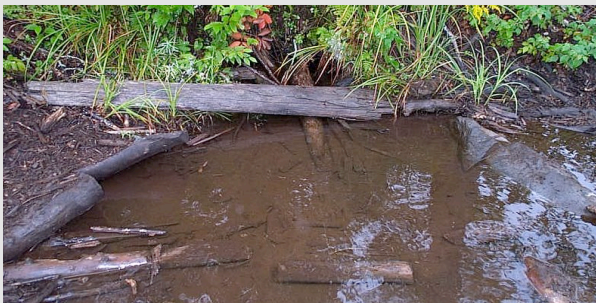
### Moderate

Accumulation of sediment downstream of crossing is approximately 2- 6 cups greater than upstream

Erosion channels or embedded footprints or tire tracks on stream banks or within the stream channel that are 2-6 inches deep

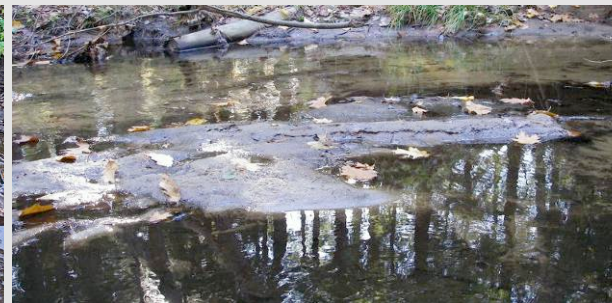
### Severe

Accumulation of sediment downstream of crossing is approximately 6+cups greater than upstream

Erosion channels or embedded footprints or tire tracks on stream banks or within the stream channel that are 6+ inches deep

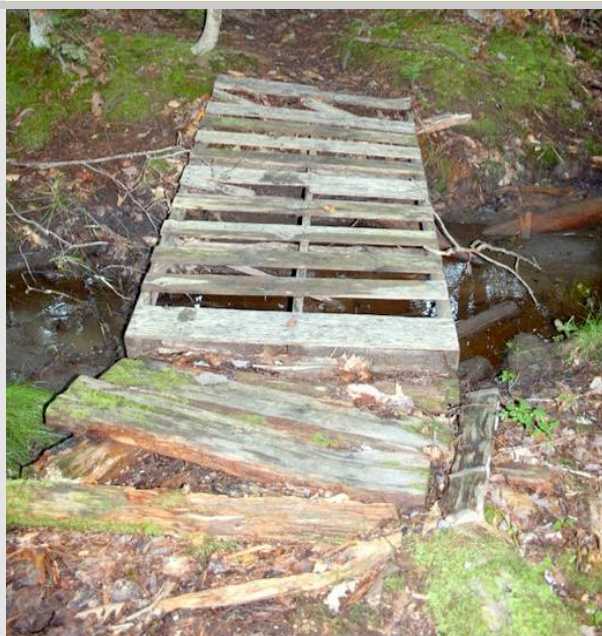
### Moderate

Conditions that are likely to cause injury or harm to users now or in the near future (<12 months)

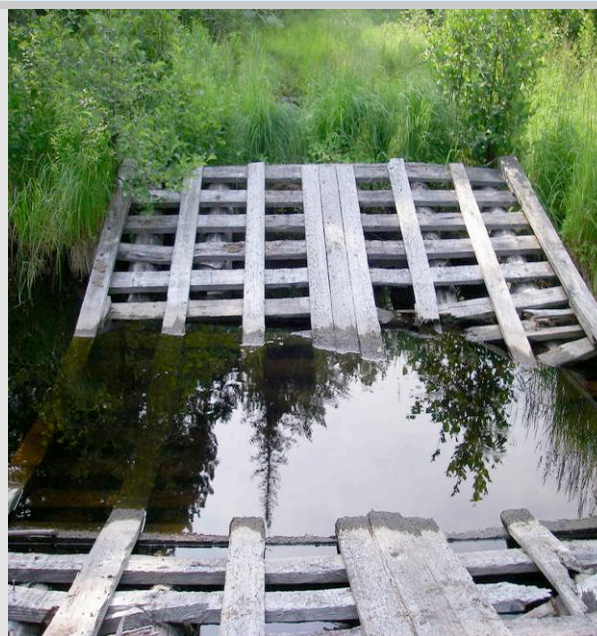
### Severe

Conditions that are very likely to cause harm to users now or in the near future (<12 months)

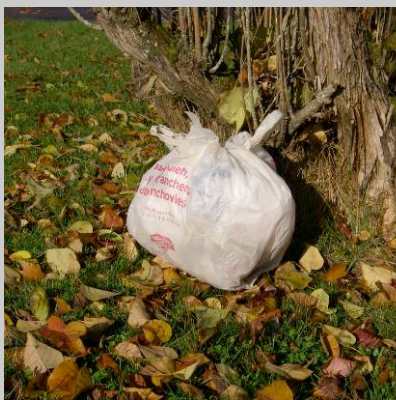
### Low

The amount of trash along the trail segment would fit in a disposable plastic grocery bag

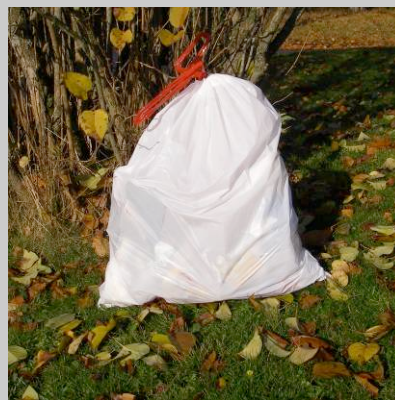
### Moderate

The amount of trash along the trail segment exceeds what would fit in a disposable plastic grocery bag but could be cleaned up using a single tall kitchen size trash bag (13 gallons)

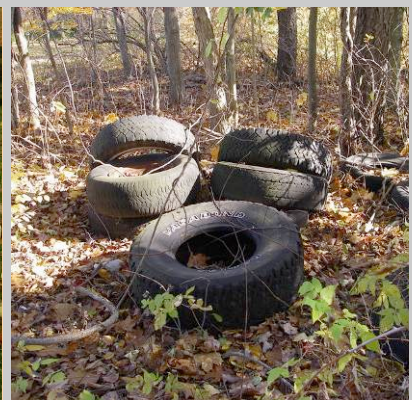
### Severe

The amount of trash along the trail segment would exceed a single tall kitchen size trash bag (13 gallons)
